NASA TN D-2274

SURFACE FAILURE OF ALUMINA BALLS DUE TO REPEATED STRESSES APPLIED IN ROLLING CONTACT AT TEMPERATURES TO 2000° F

by Richard J. Parker, Salvatore J. Grisaffe, and Erwin V. Zaretsky

Lewis Research Center Cleveland, Ohio

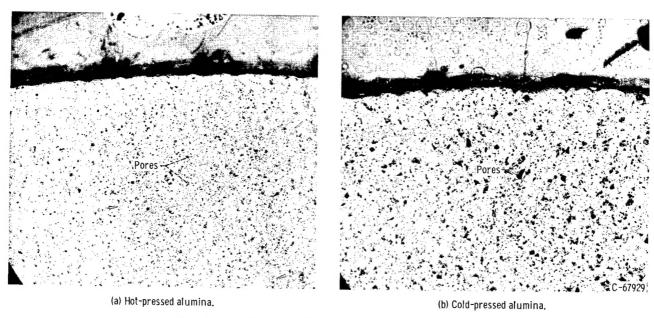
Difficulty was encountered in obtaining a good surface finish on the cold-pressed specimens. Many shallow pits as wide as 0.003 inch were observed at a magnification of 15 diameters on the surface of the as-received balls. The number and size of these pits varied among specimens. The surface finish on the hot-pressed specimens was better. Very few pits were observed (at 15 diam) on these specimens; those that were observed were similar in appearance to those on the cold-pressed specimens but smaller in size. Photomicrographs of metallurgically polished cross sections of the two materials are shown in figure 1. The pores in the cold-pressed alumina are larger, which may account for

Figure 1. - Photomicrograph of section of alumina ball specimen, X60.

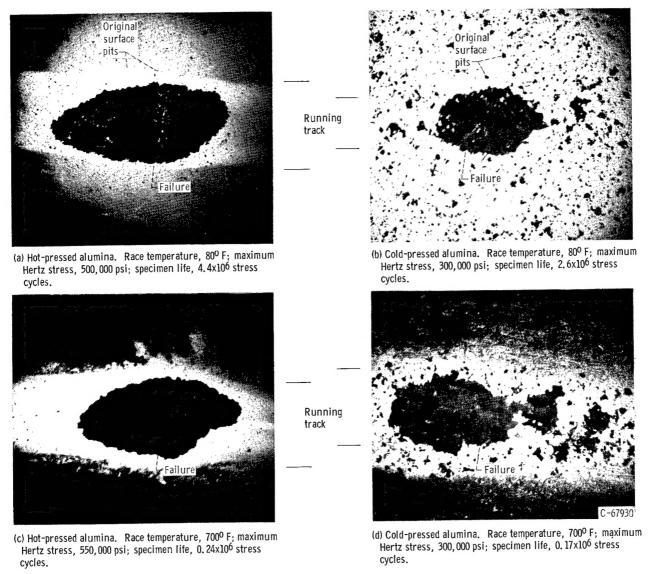
Typical failure pits in alumina test balls are shown in figure 5. These pits were shallow, eroded areas averaging about 1 mil deep and were unlike the deeper

fatigue spalls observed in bearing steels and a crystallized-glass ceramic (ref. 4).

In nearly all tests, the failure started at a small pit in the original ball surface and progressed in size to the full track width. These small pits can be seen in figures 5(a) and (b) in the areas outside the running track. The pits or pores in the original surface of the cold-pressed alumina (fig. 5(b)) were several times larger than those in the hot-pressed alumina (fig. 5(a)).

The progression of the pores or pits to full-track-width pits was a slow, erosive process frequently consuming one-half the total running time of the

Figure 5. - Typical failure pit on alumina test ball specimens. X65.

specimen. In nearly every test, several smaller failure pits were at various stages of progression when the largest pit reached the width of the running track.

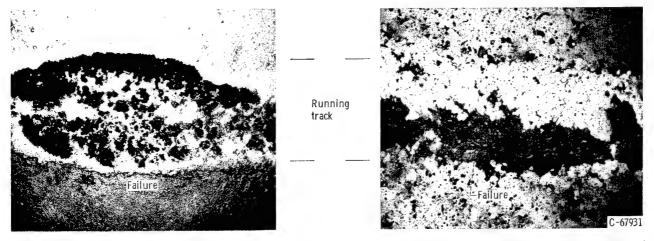
The pitting in hot-pressed alumina at 2000° F closely resembled the failure pits produced in the lower temperature tests. Figure 8(a) is a photomicrograph of the pit that occurred in test 2 (table III).

A photomicrograph of a portion of the track of the cold-pressed alumina ball tested under identical conditions (test 3) is shown in figure 8(b). This test was stopped at this point because it was apparent that a general track breakdown was occurring. The failure pit had not yet reached full track width when it became excessively long in the direction of the track. This failure process, also observed in test 1, was unlike that obtained with cold- and hot-pressed alumina at 80° and 700° F or hot-pressed alumina at 2000° F.

As shown in table III, the hot-pressed alumina had been subjected to about five times as many stress cycles as the cold-pressed alumina when the failures occurred. Although both specimens were tested at a maximum Hertz stress of 341,000 psi, the two tests should not be directly compared because of the

(a) Hot-pressed alumina. Maximum Hertz stress, 341,000 psi; specimen life, 0.19x10⁶ stress cycles.

(b) Cold-pressed alumina. Maximum Hertz stress, 341,000 psi; specimen life, 0.04x10⁶ stress cycles.

Figure 8. - Typical failure pits on alumina ball specimens. Temperature, 2,000° F. X65.

peculiar failure on the cold-pressed specimen.
